APPENDIX C—Images of first-floor structural failure (images from Figures 2a and 2b)

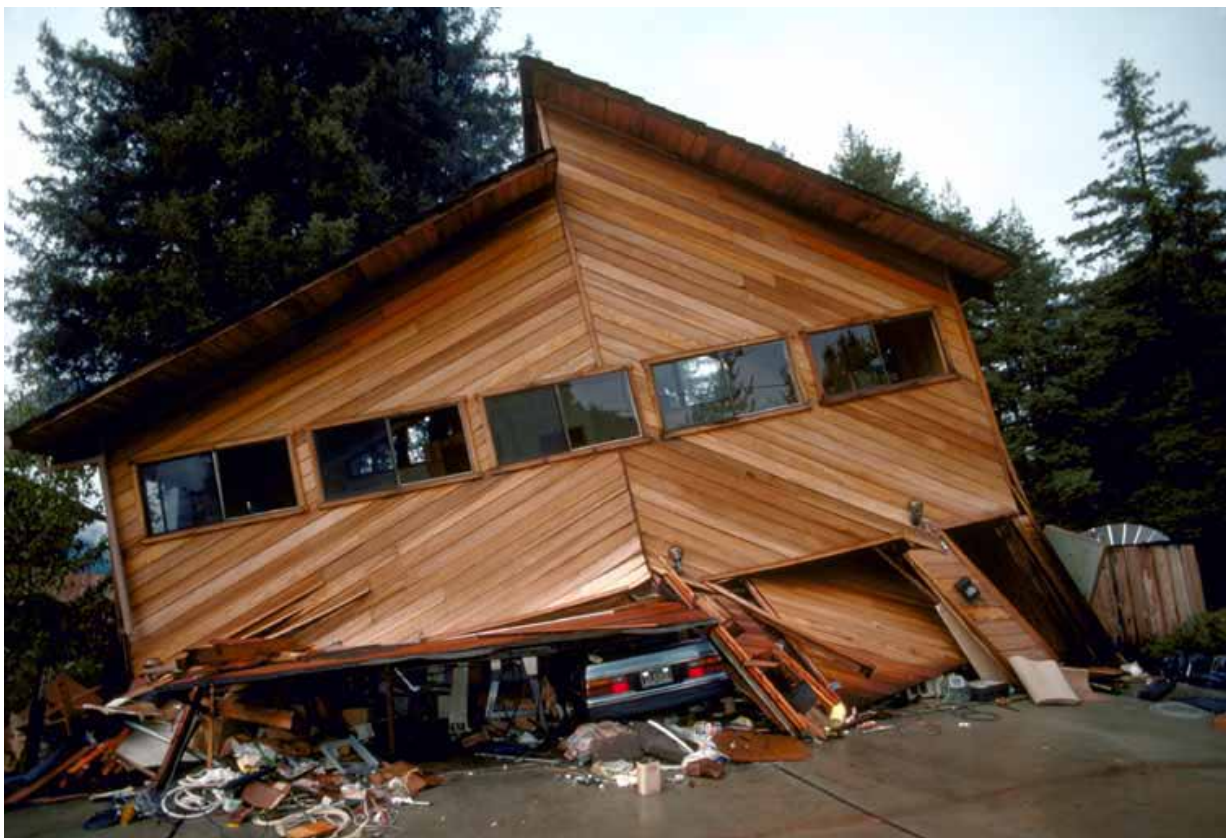
Soft first floor garage, lacking shear strength, causes house to collapse during strong shaking. Image source: [U.S. Geological Survey](#)

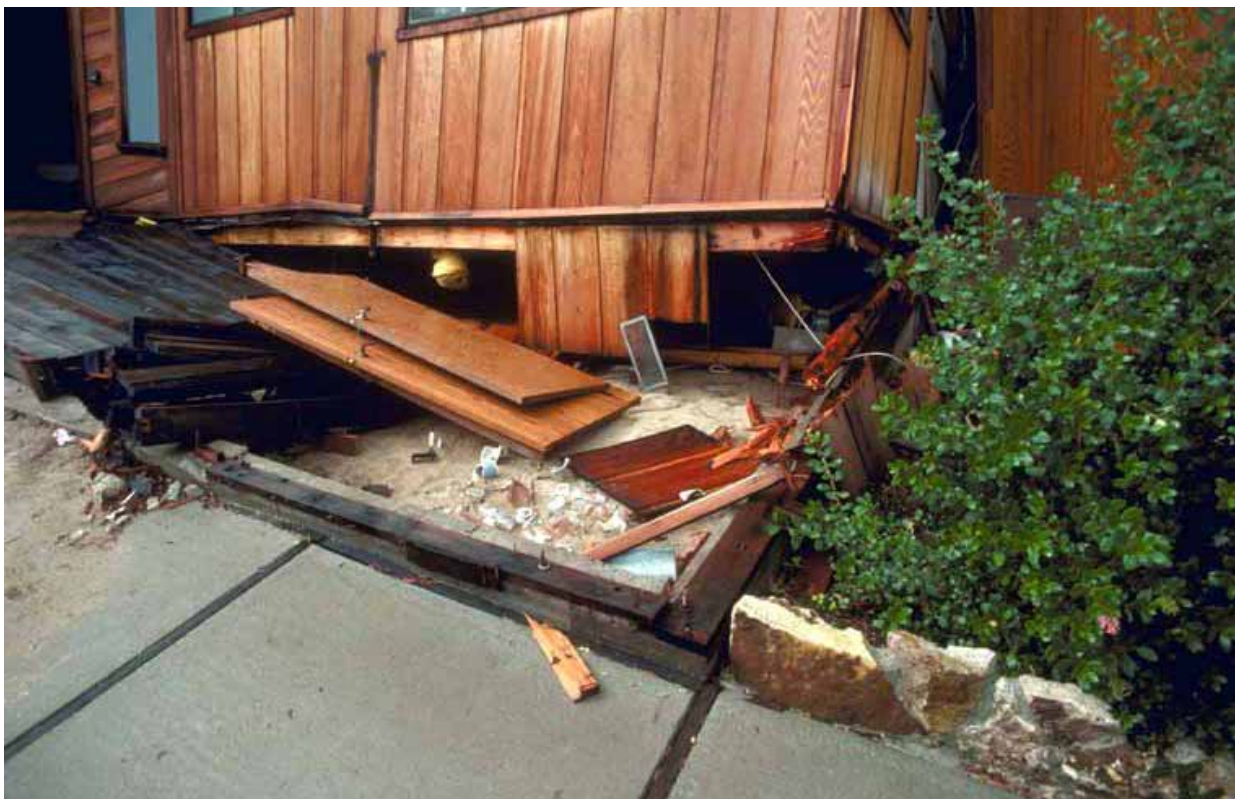
Cripple wall lacking shear strength contributed to house collapse. Image source: [U.S. Geological Survey](#)
